Re: Structural Assessment  
Commerce Public Library  
1210 Park Street, Commerce, TX 75428  
JQ Project No: 3123332

Jaster-Quintanilla (JQ) performed a limited, structural review of the Commerce Public Library Building on April 13, 2012 in accordance with our proposal dated 03/27/12. The purpose of the review was to document the existing conditions of the structure and observed deficiencies, provide recommendations for repair, and provide an opinion of probable construction cost for the recommended repairs.

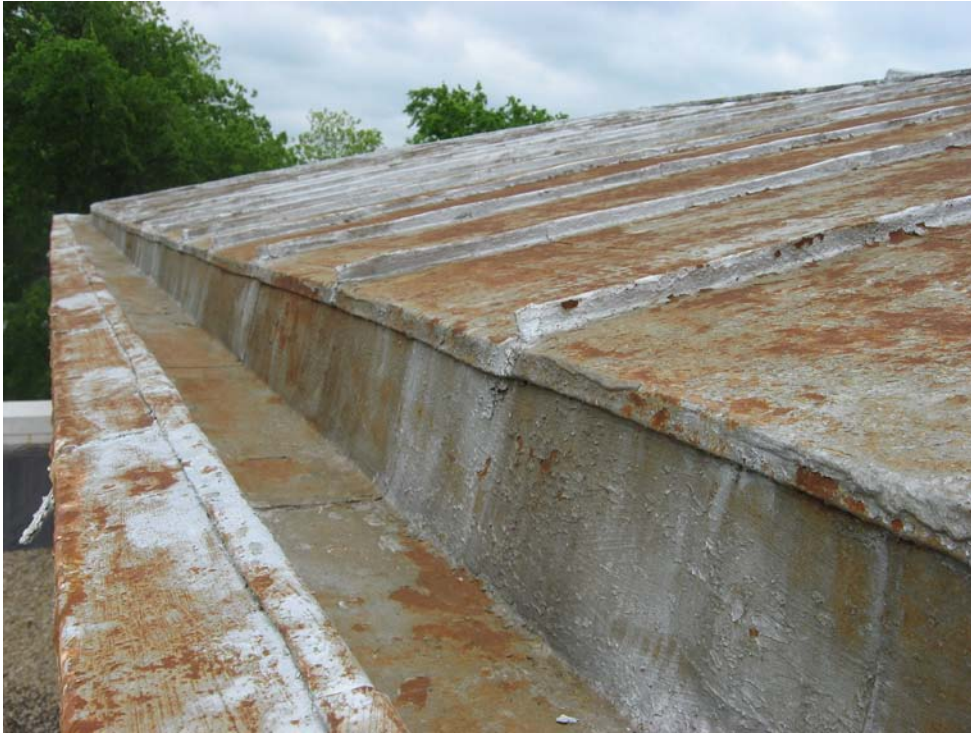
The standing seam tin roof appears to have received a coating at some previous point in time. However, the majority of the coating has deteriorated, and rust has begun to form on the surface of the tin (Photo P6-1). The flashing at the portico roof-to-parapet wall joint was observed to be deteriorated (Photo P16-2).

Photo P6-1 – Concealed tin-lined gutter at upper roof. Note deteriorated coating and corrosion on tin.

1. Remove and replace roof membrane, flashings and counterflashings at low roof.
2. Clean and coat tin roof and concealed gutters.
3. Seal vertical control joint between original building and east addition.
4. Seal cracks in entry porch and front steps.
5. Replace missing and deteriorated wood trim elements, seal joints, and clean and paint all exterior wood trim.
6. Restore, clean and paint all wood windows.

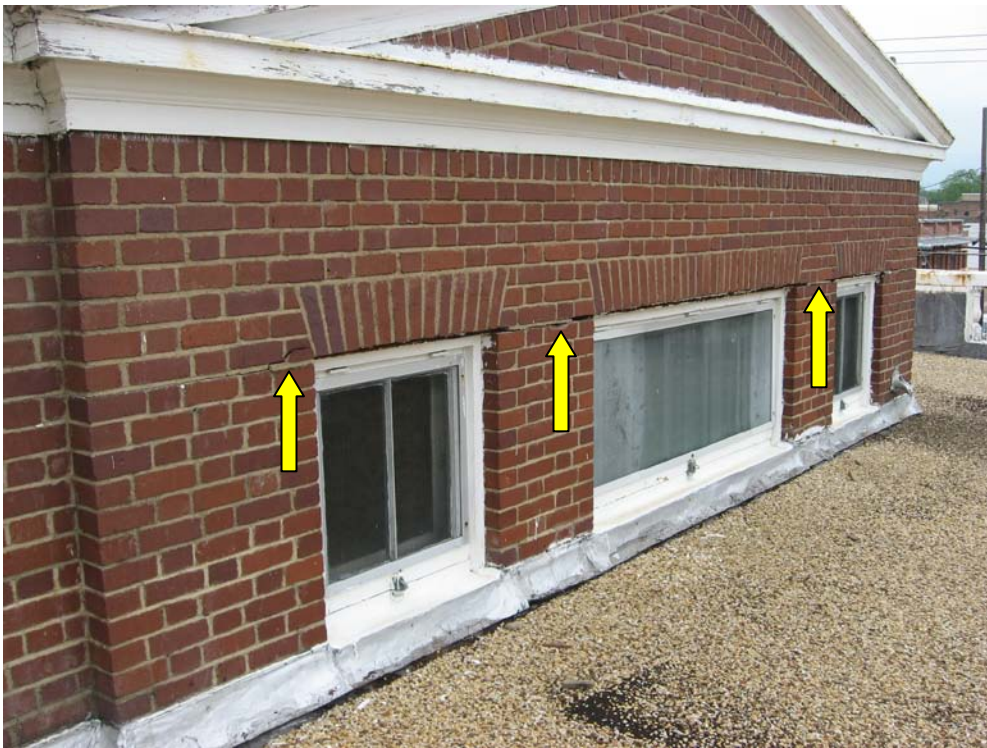
On the exterior, some deterioration of brick mortar joints and broken brick units was observed on the north, west and south elevations at the upper walls of the Second Floor (Photos P8-2 and P9-1). Some

Photo P8-2 – Deteriorated mortar joints and broken brick units, North Elevation, Second Floor.

1. Remove the large trees from the west side of the building.
2. Re-grade the areas adjacent to the North and West Elevations to provide positive slope for surface water and water deposits from downspouts to be directed away from the building.
3. Replace concrete drainage channel at northwest corner of building.
4. Repair spalled sections of concrete on underside of First Floor slab.
5. Clean areaways, and restore drains to a functioning condition.
6. Remove and replace deteriorate mortar from brick joints. Fill holes and gaps in brick mortar joints.
7. Repair spalled section of limestone.
8. Clean and coat exposed portions of steel lintels at all windows.
9. Repair, seal, and coat the column surrounds at the entry portico.

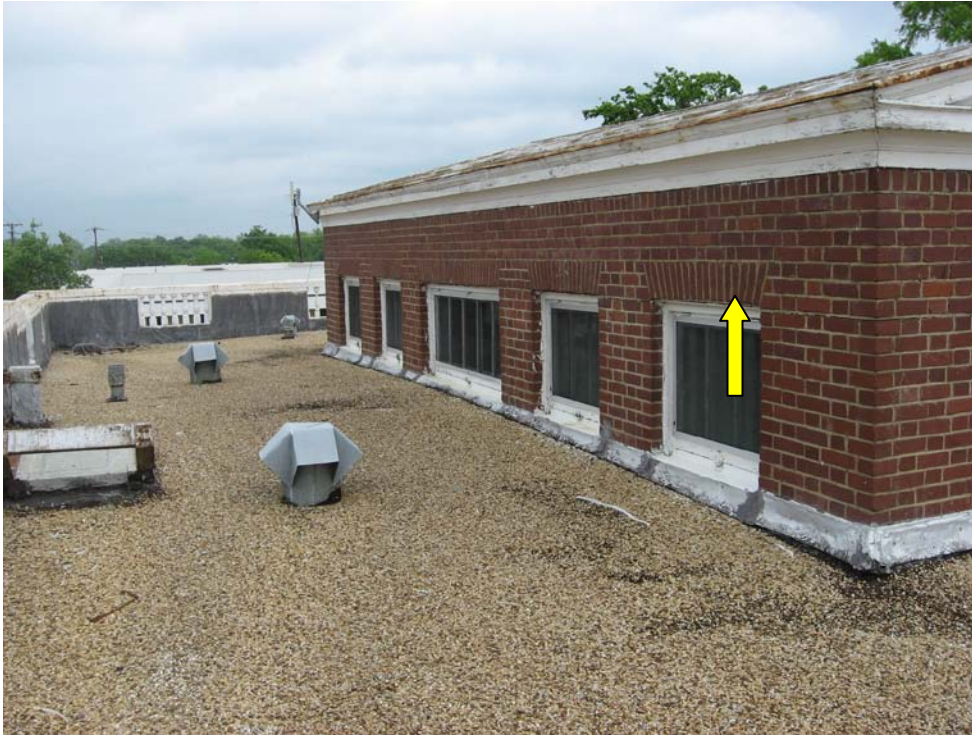
P9-1 – Deteriorated brick mortar joints, West Elevation, Second Floor.

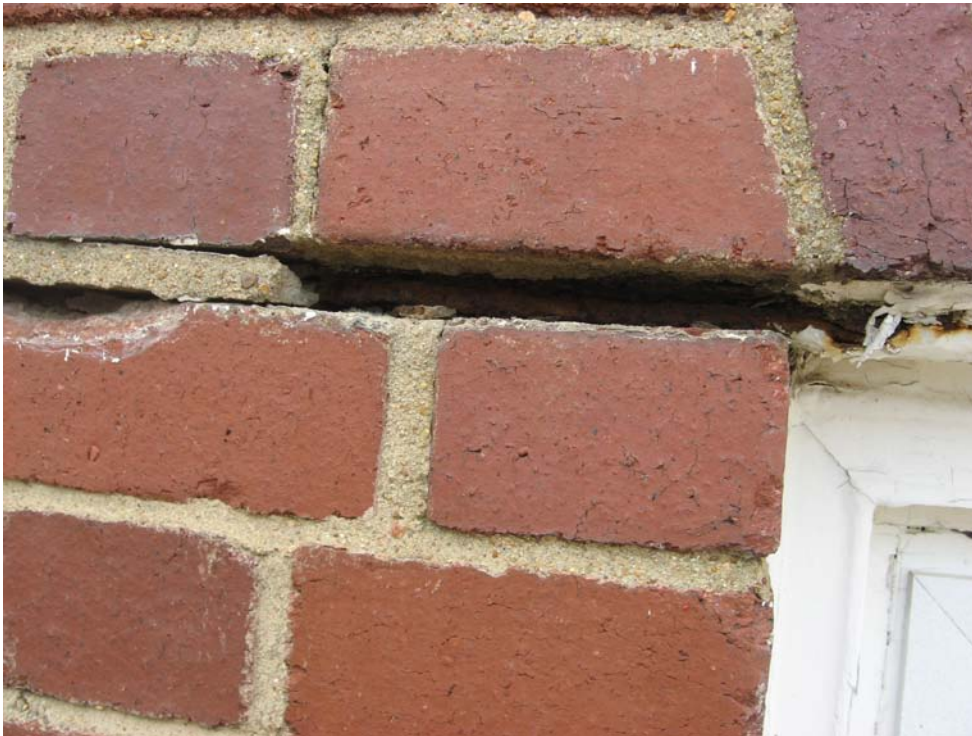
of deterioration appears to be the result of corrosion of the embedded steel angle lintels over the window openings (Photo P9-2). Stair-stepped cracks in the brick were observed at the northwest and southwest corners (Photo P10-1). Minor holes and gaps in the mortar were observed at several other locations on the exterior elevations (Photo P10-2).

Photo P9-2 – Corrosion on embedded steel lintel.

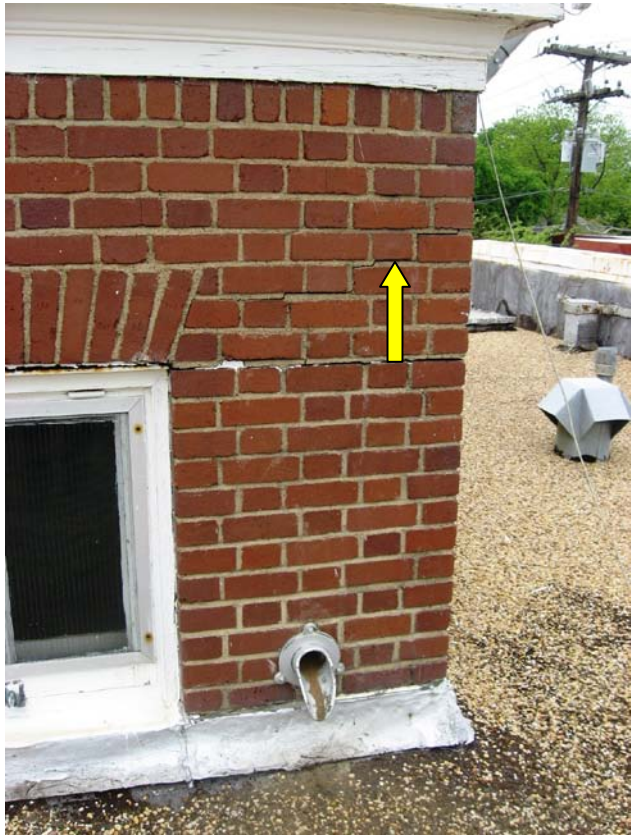
At the northwest and southwest corners of the building, it is our opinion that a combination of the two items listed above has contributed to the stair-stepped cracks in the masonry at the exterior corners of the Second Floor, and the crack observed in the northwest corner of First Floor slab.

Photo P10-1 – Stair-stepped cracks at northwest corner.

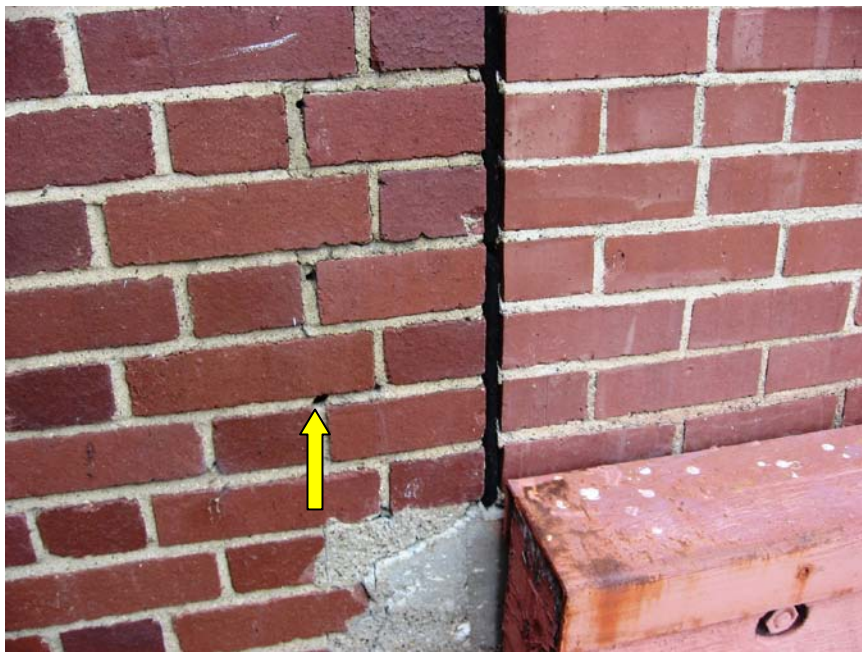
The vertical control joint between the original building and the east addition was observed to be inadequately sealed (Photo P10-2).

Photo P10-2 – Minor holes in mortar joints, South Elevation. Note joint is not adequately sealed.

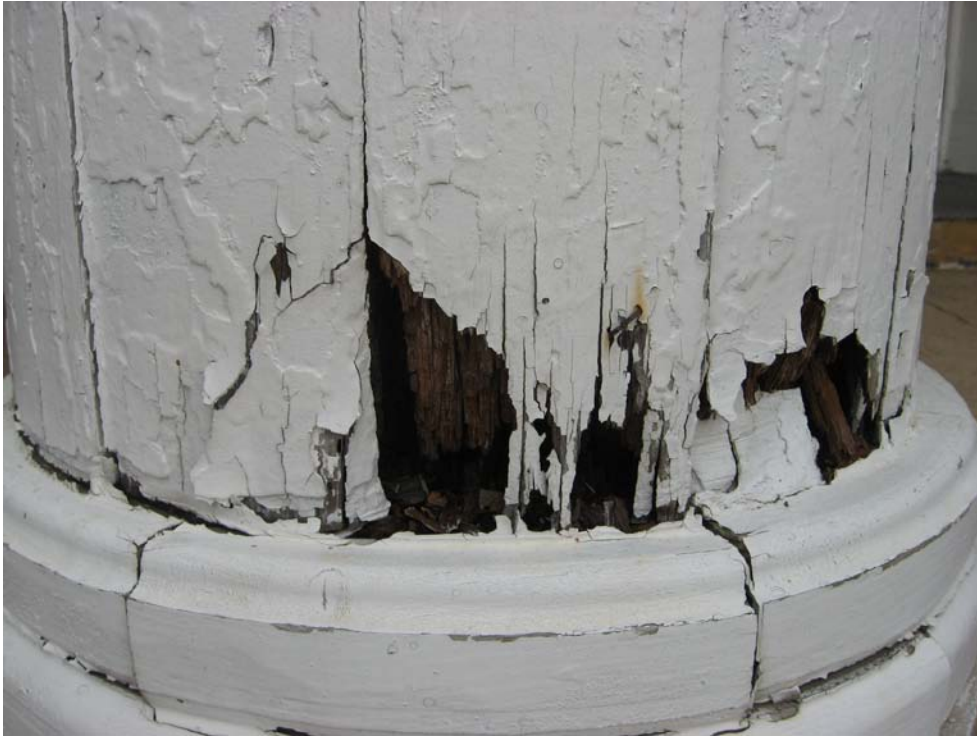
Deterioration of the wood column surround was observed at one of the columns at the entry portico (Photo P11-1). Probing of a portion of the inner 6x6 support column did not reveal any softness or deterioration.

Photo P11-1 – Deteriorated wood at column surround, entry portico, West Elevation.

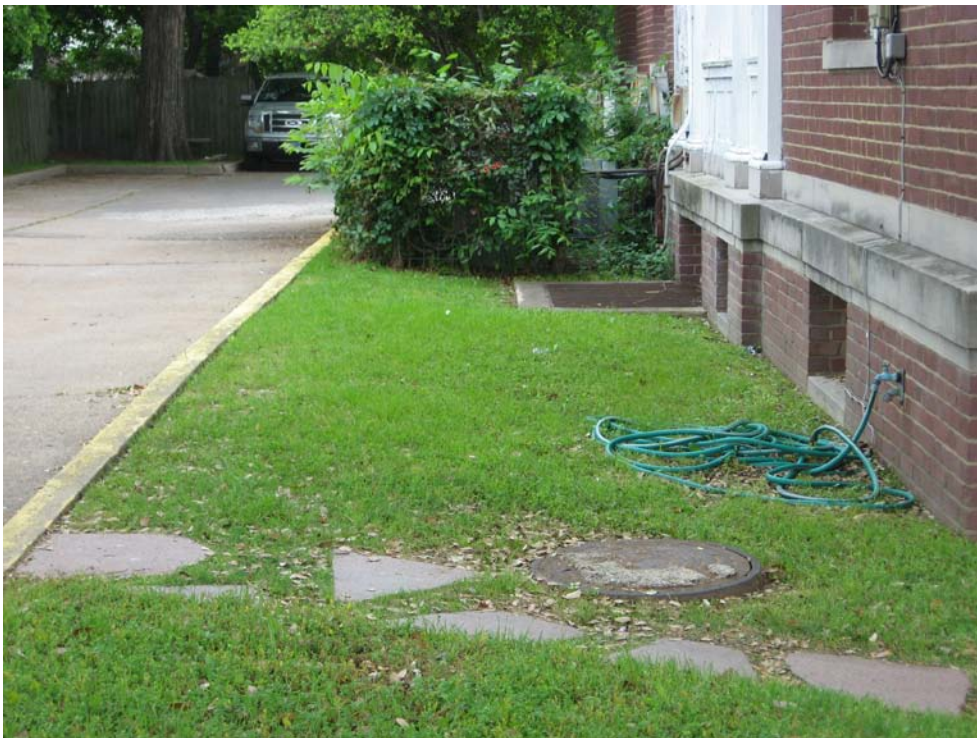
The ground adjacent to the north and west sides of the building was observed to be sloping back toward the building (Photo P11-2). A concrete channel at the northwest of the building intended to drain water from a downspout away from the building also was observed to be sloping back toward the building (Photo P12-1).

As noted previously, the majority of the deficiencies noted for the Commerce Public Library are related to moisture infiltration, and the lack of positive drainage away from the building. Providing positive slope that allows surface water to drain away from buildings is a major component in reducing the potential for water to accumulate along building foundations, and moisture infiltration into below-grade areas.

Photo P11-2 – Grade along North Elevation slopes back toward building.

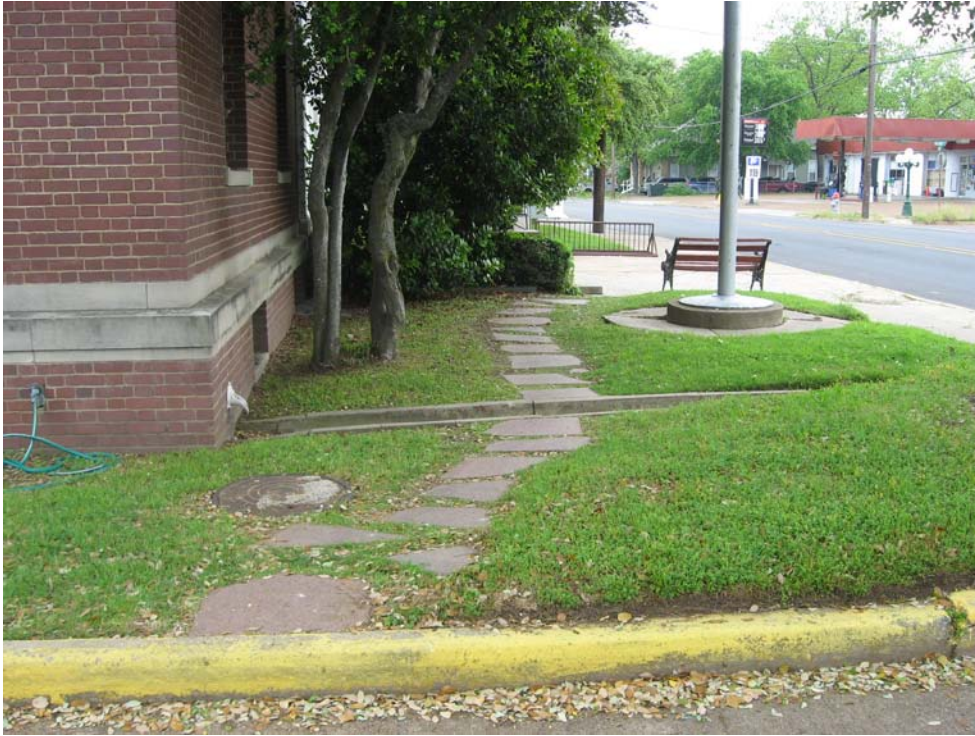
P12-1 – Grade and concrete drainage channel slope back toward building, West Elevation.

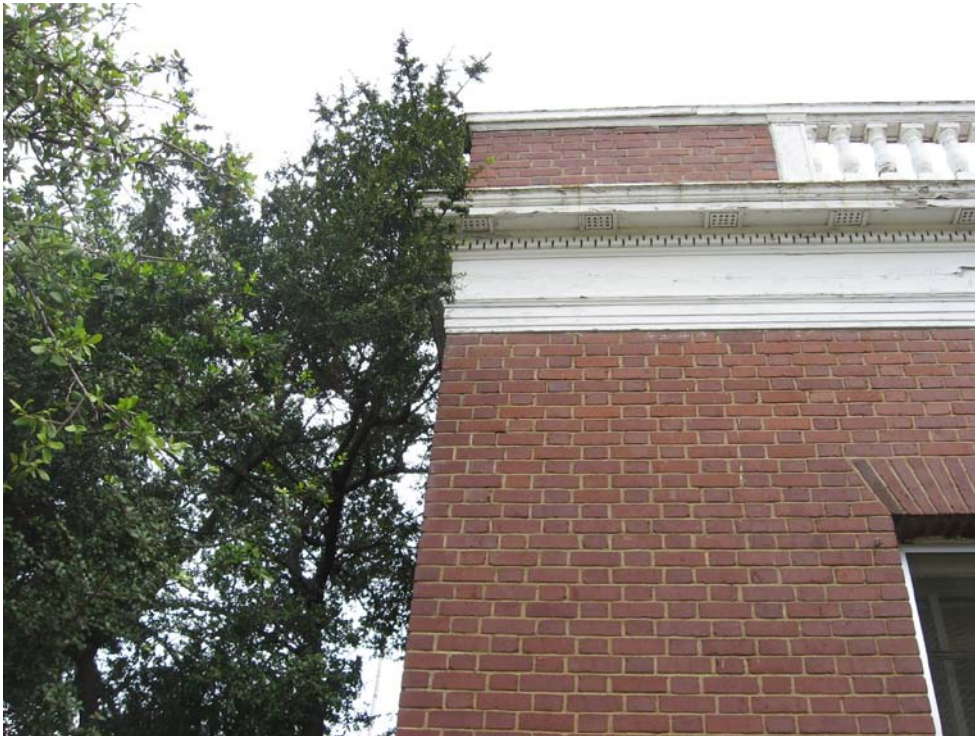
Large trees and other vegetation were observed in close proximity to the west elevation of the building. Some of the tree branches were observed to be in contact with the building (Photo P12-2).

In most cases, Geotechnical Engineers in this part of Texas do not recommend placing large trees in close proximity to buildings supported on shallow foundations. With extended root systems, the trees can desiccate (dry out) the active clay soils supporting the building, causing the soil to shrink, and resulting in an increased potential for settlement.

Photo P12-2 – Tree branches in contact with building, southwest corner.

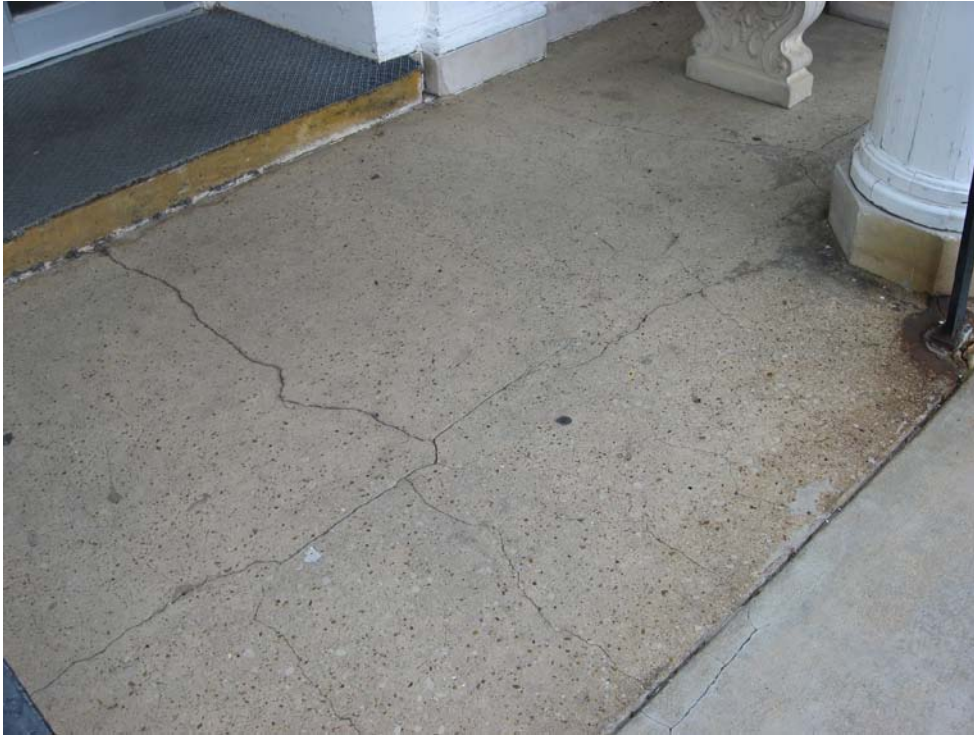
Minor cracks were observed in the concrete entry steps and porch (Photos P13-1 and P13-2). Deteriorated brick mortar joints were observed at the south abutment flanking the entry steps (Photo P14-1).

Photo P13-1 – Cracks in concrete at entry porch.

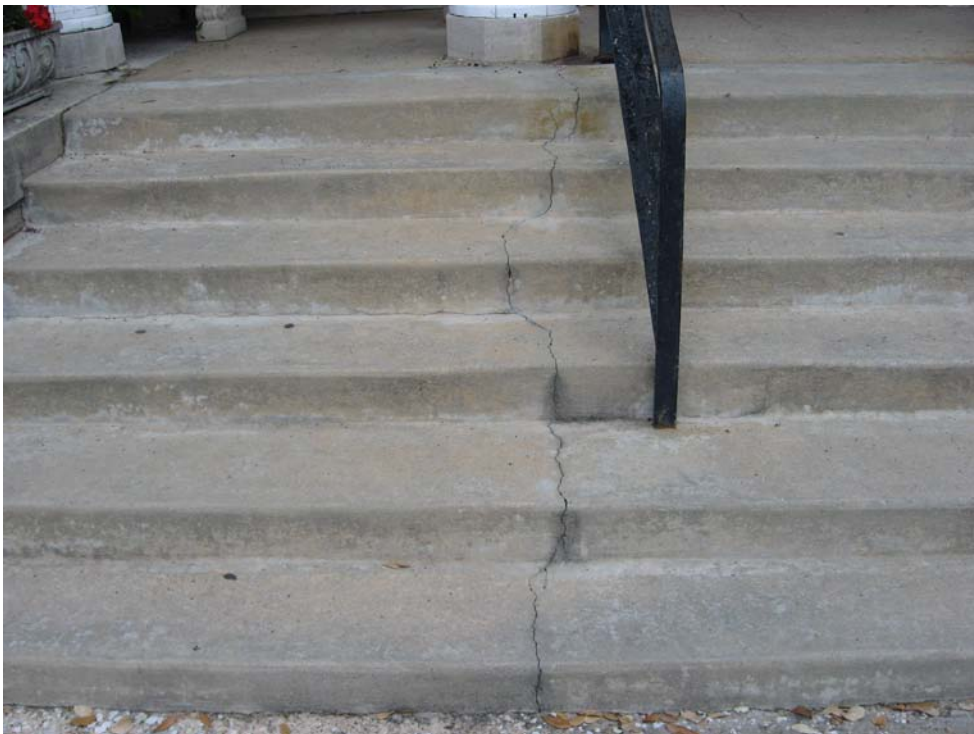
Photo P13-2 – Cracks in concrete entry steps.

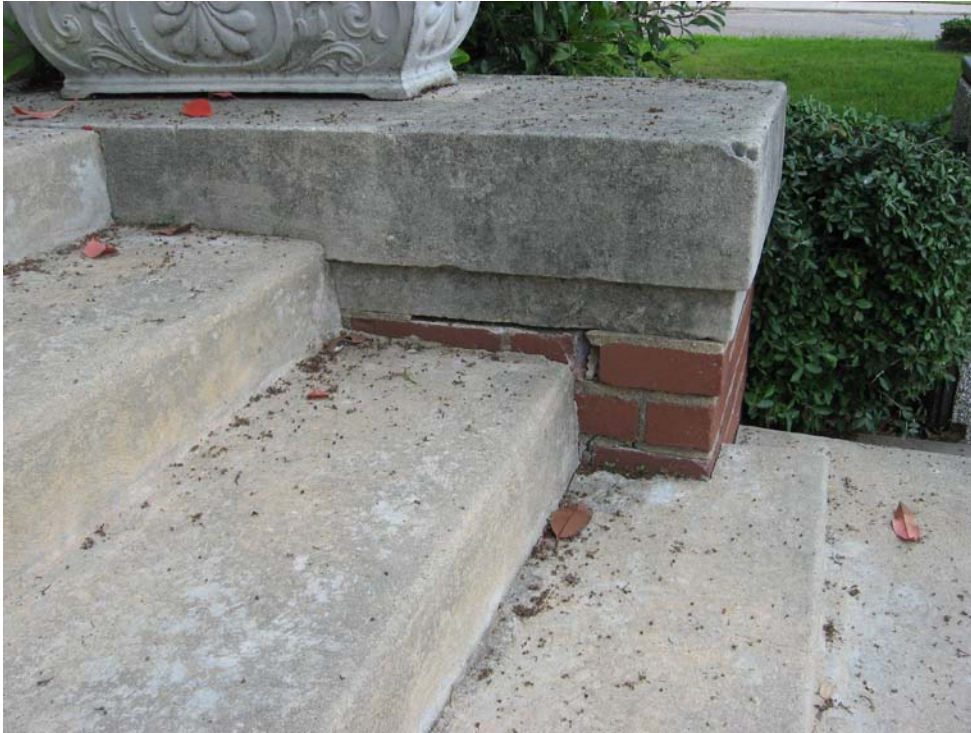
Photo P14-1 – Deteriorated brick mortar joints, south abutment at entry steps.

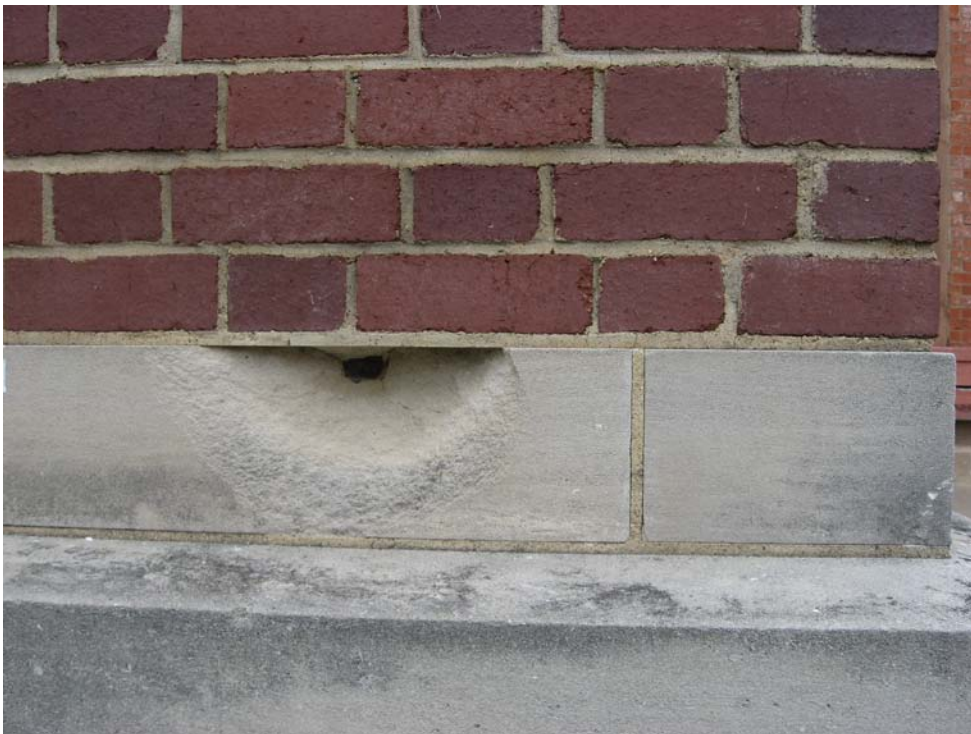
One piece of the limestone water table located at the southeast corner of the building was observed to be spalled, exposing a mildly corroded metal anchor (Photo P14-2).

Photo P14-2 – Spalled piece of limestone with exposed anchor, southeast corner.

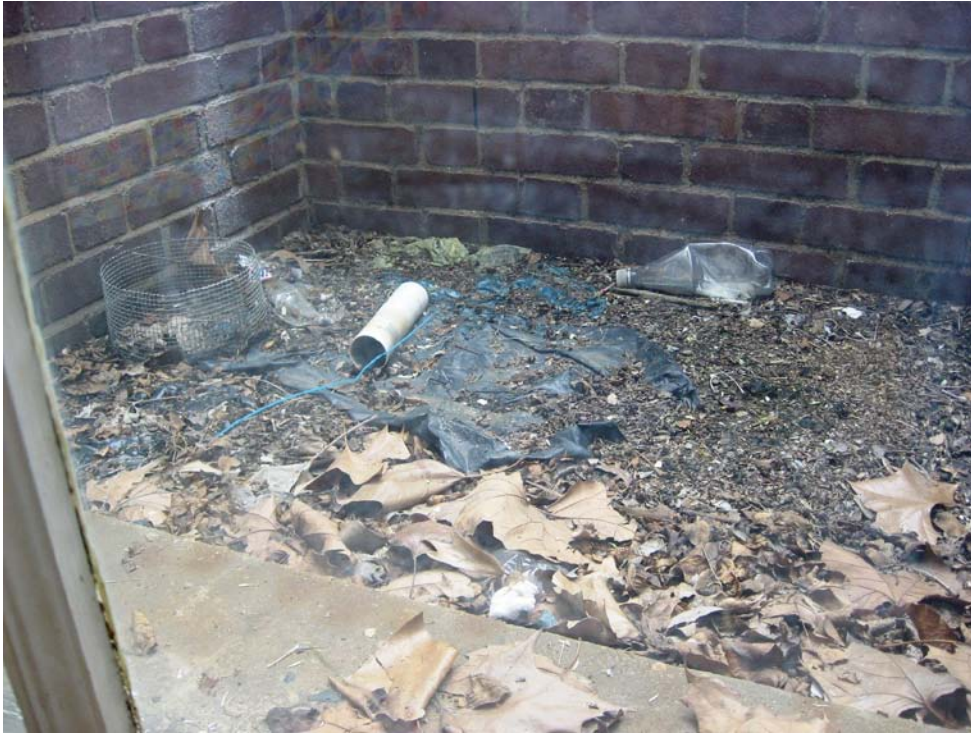
All four areaways were observed to contain significant amounts of debris (Photo P15-1). It is unknown if the drains in the areaways are functioning.

Photo P15-1 – Debris at areaway, south side of building.

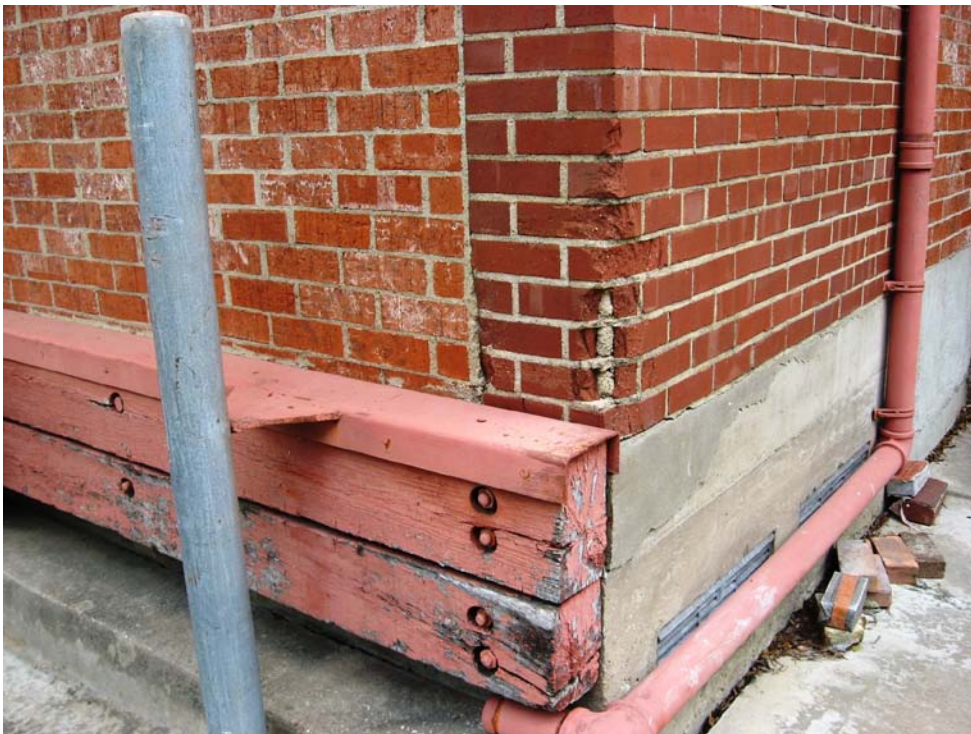
Broken bricks were observed at the northeast and southeast corners of the east addition (Photo P15-2).

Photo P15-2 – Broken brick at northeast corner of east addition.

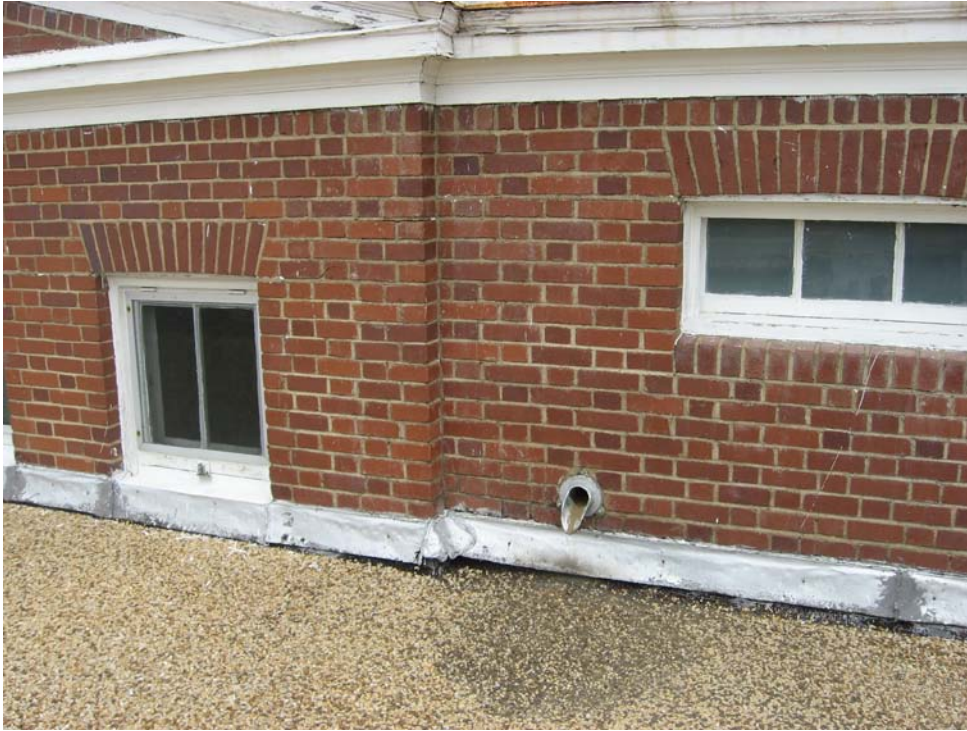
The age of the low roof membrane is unknown, but it appears to be approaching the end of its useful life. Roof drains from the upper roof deposit water onto the membrane of the lower roof (Photo P16-1). Flashing and counterflashing elements also are showing signs of deterioration.

Photo P16-1 – Water from upper roof is deposited onto lower roof.

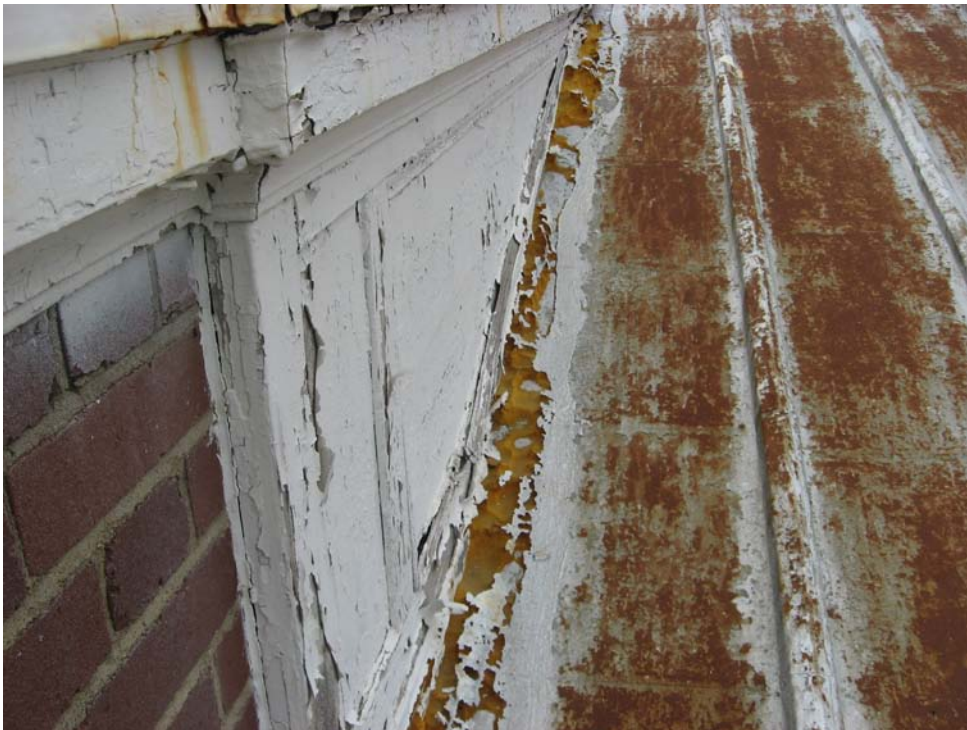
Photo P16-2 – Deteriorated flashing at portico roof-to-parapet wall connection.

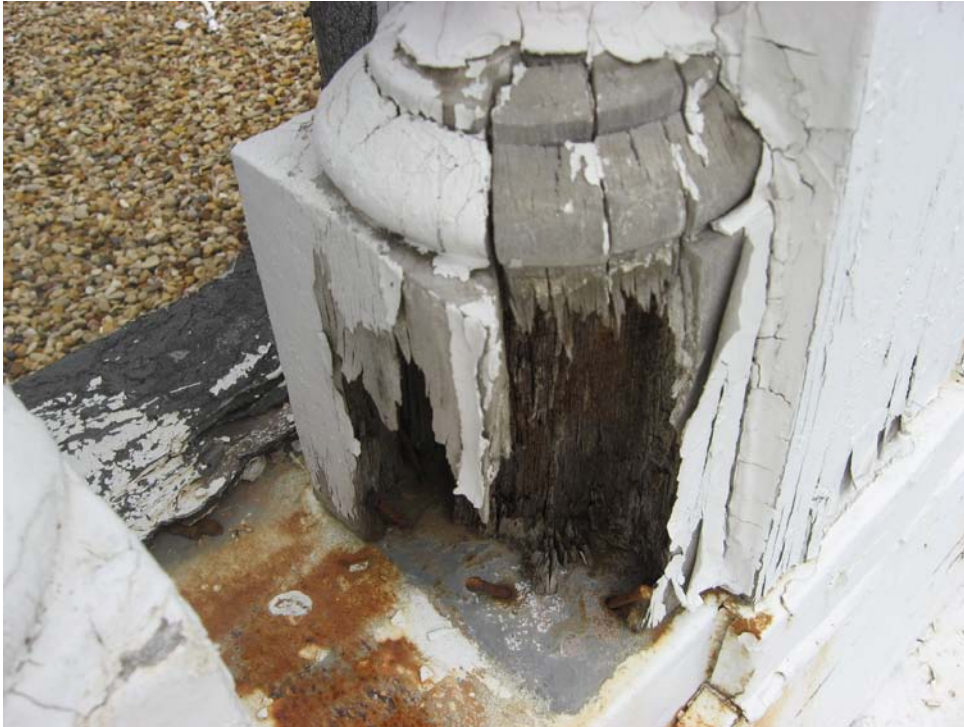
The wood balusters that make up the balustrades at the low roof level were observed to be in fair to poor condition (Photo P17-1), with some missing pieces (Photo P17-2).

Photo P17-1 – Severely deteriorated wood baluster.

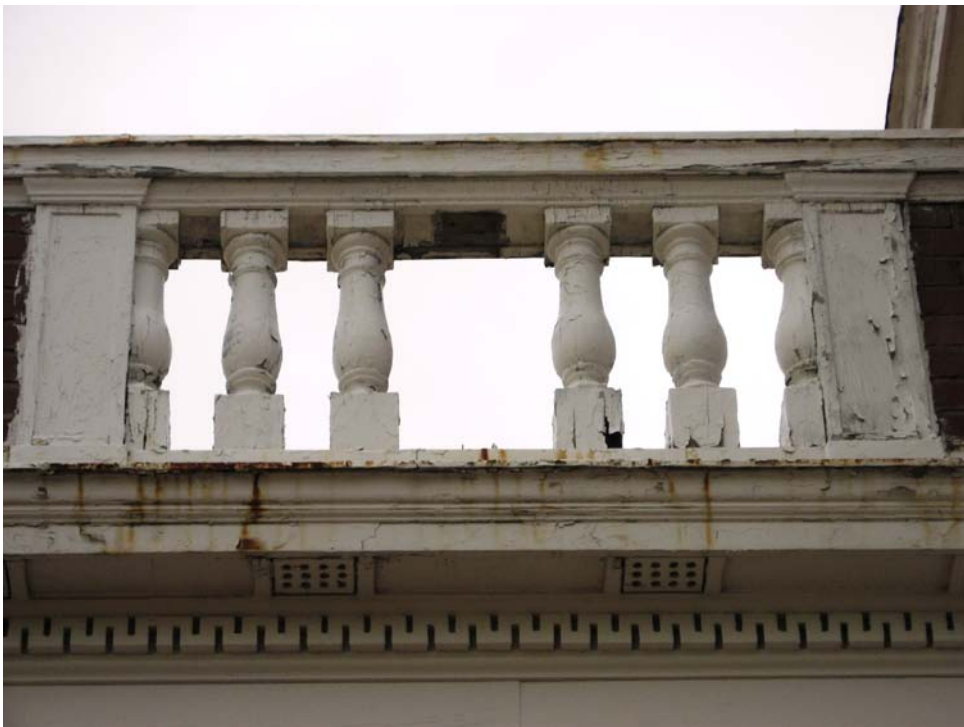
Photo P17-2 – Missing baluster.

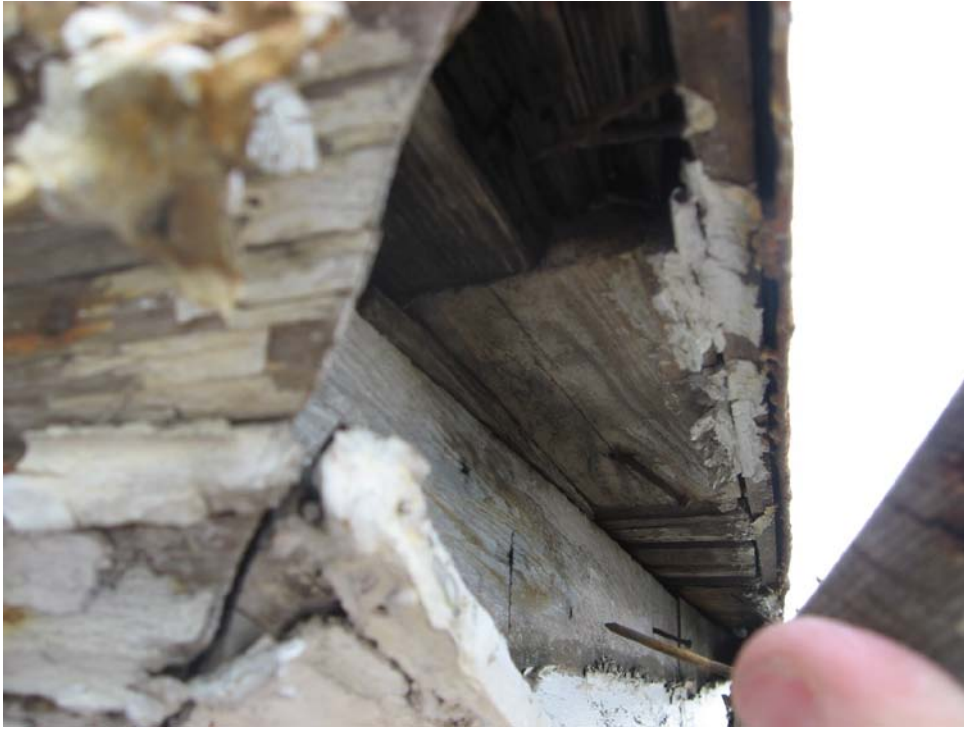
Much of the exterior wood trim and wood window elements were observed to be in fair to poor condition, with peeling paint and open joints. Some sections of the wood trim were loose (Photo P18-1), and a few sections were missing (Photo P18-2).

Photo P18-1 – Loose section of wood trim along upper roof, North Elevation.

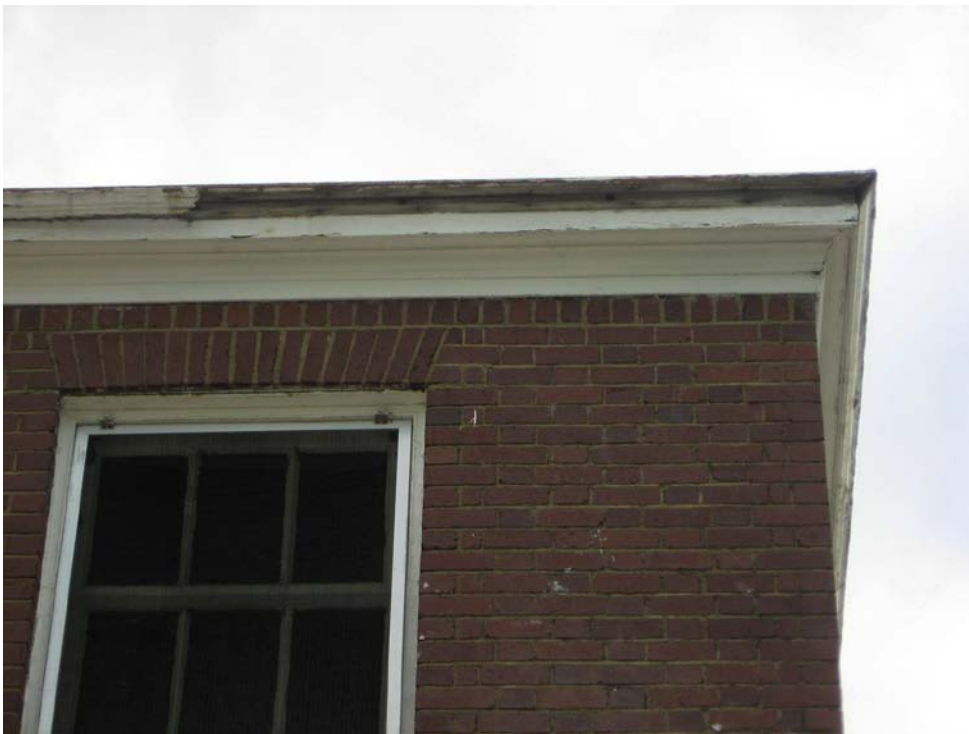
Photo P18-2 – Missing section of wood trim, upper roof, East Elevation.

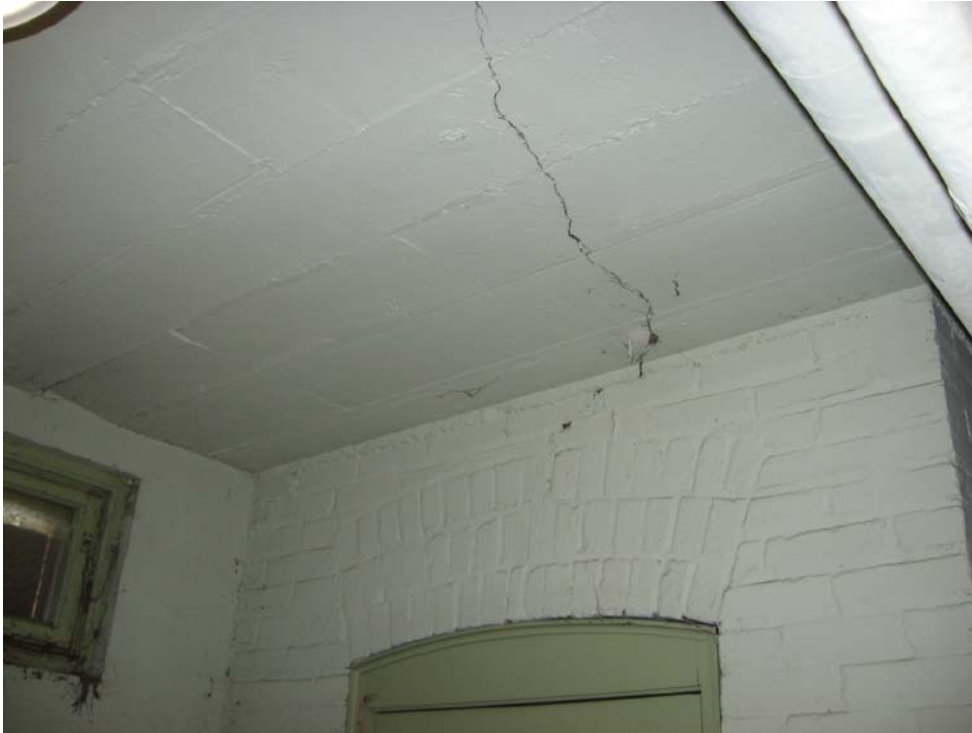
On the interior of the building, the structural elements were observed to be in good condition. One crack in the First Floor slab was observed in the northwest corner (Photo P19-1), and another at the east side of the First Floor (Photo P19-2). Most likely, these cracks are the result of some minor settlement and do not require repair. However, they should be monitored.

Photo P19-1 – Crack in underside of First Floor slab, northwest corner.

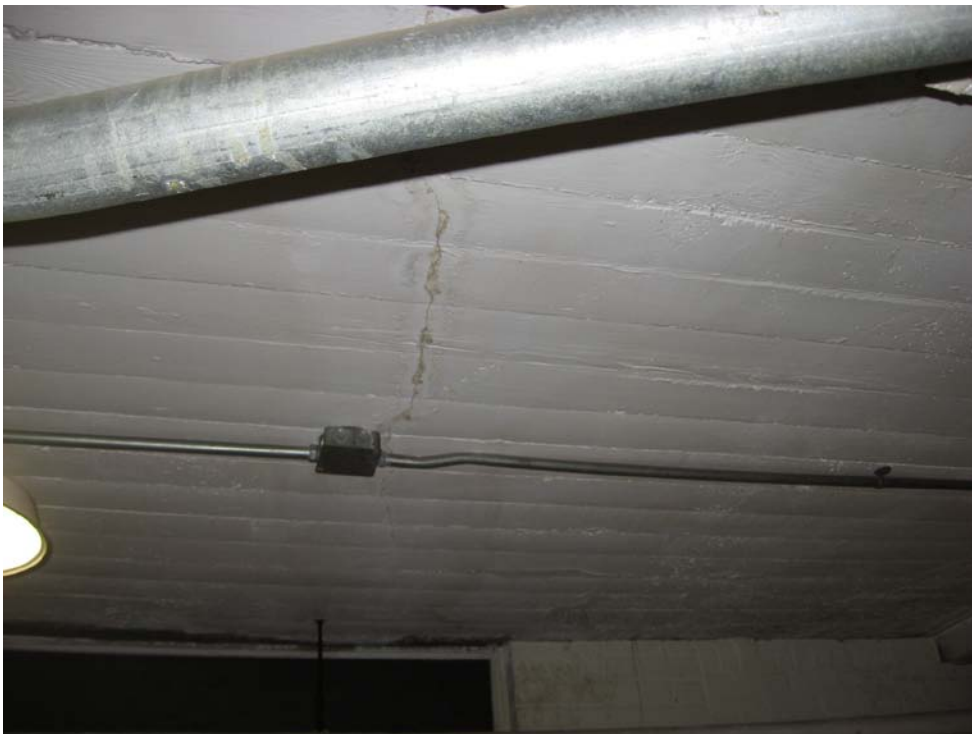
Photo P19-2 – Crack in underside of First Floor slab, east side of building.

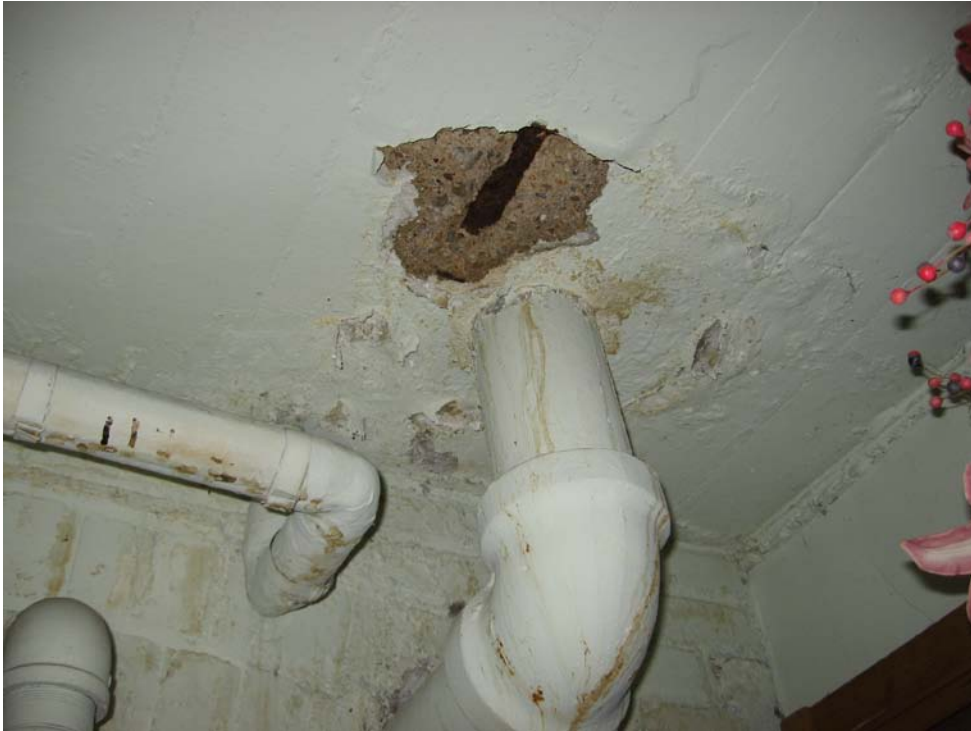
Spalled concrete with exposed steel reinforcing was observed at the few locations on the underside of the First Floor slab. One location adjacent to a drain pipe was observed to have mild corrosion (Photo P20-1).

Photo P20-1 – Exposed and mildly corroded reinforcing steel at underside of First Floor slab.

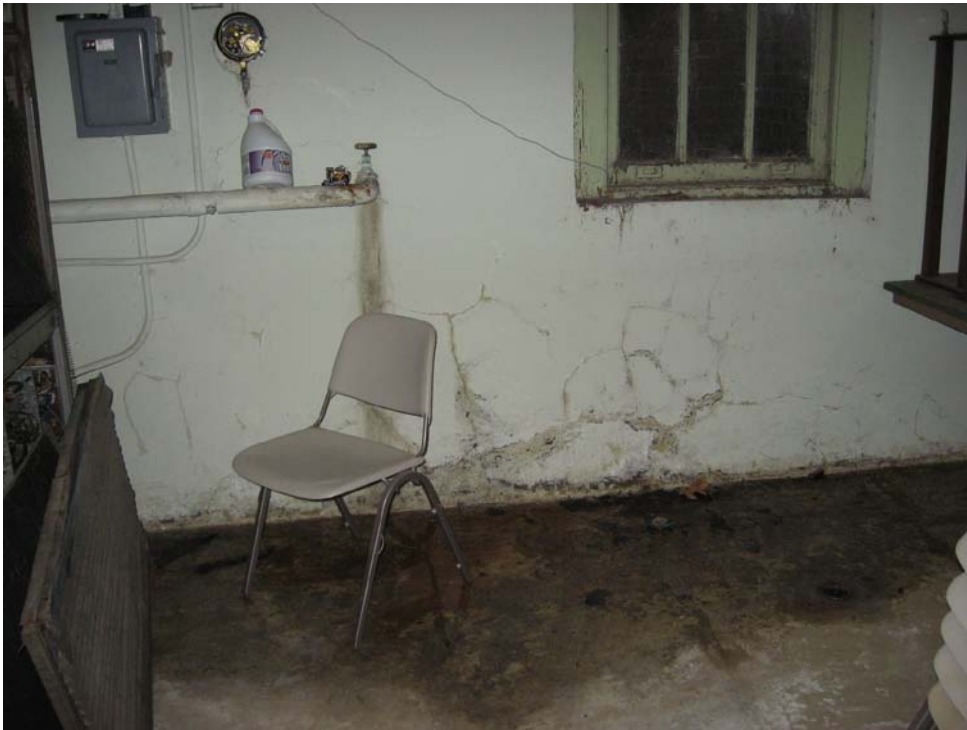
A small amount of water infiltration into the Basement was noted along the northern portion of the west elevation (Photo P20-2), where the ground and drainage channel slope back toward the building. Damaged plaster also was observed on the west wall of the west stair between the First Floor and Basement level (Photo P21-1).

placed under the Basement slab and around the foundation are no longer functioning because of clogs created by tree roots.

Photo P20-2 – Water infiltration along west wall, Basement Level.

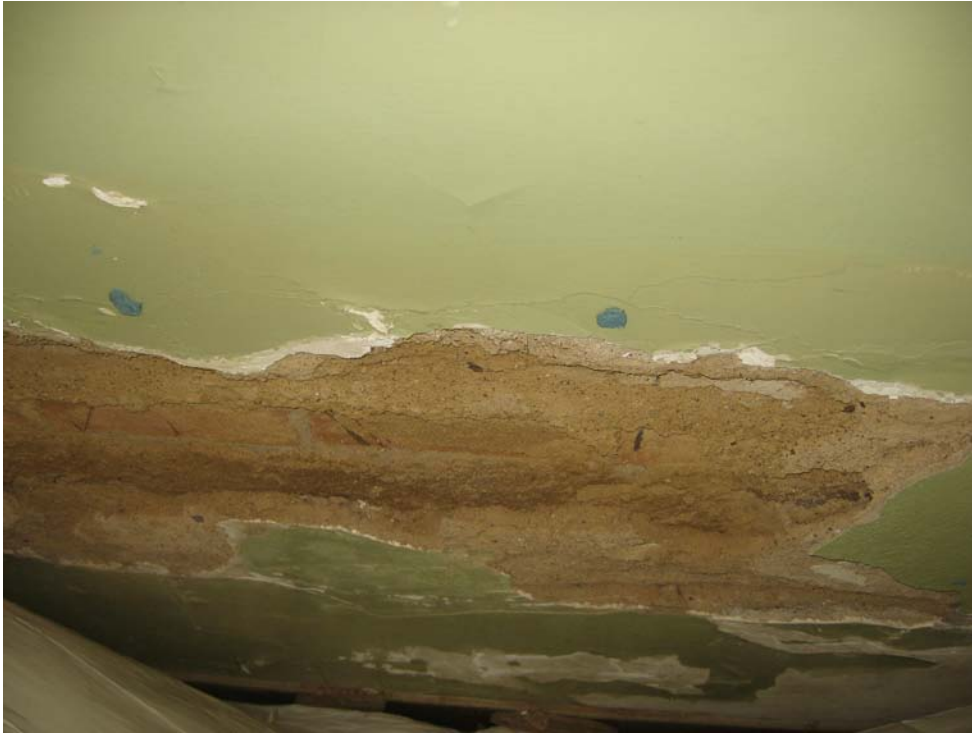
Photo P21-1 – Damaged plaster on inside face of west wall, west stair between First Floor and Basement.

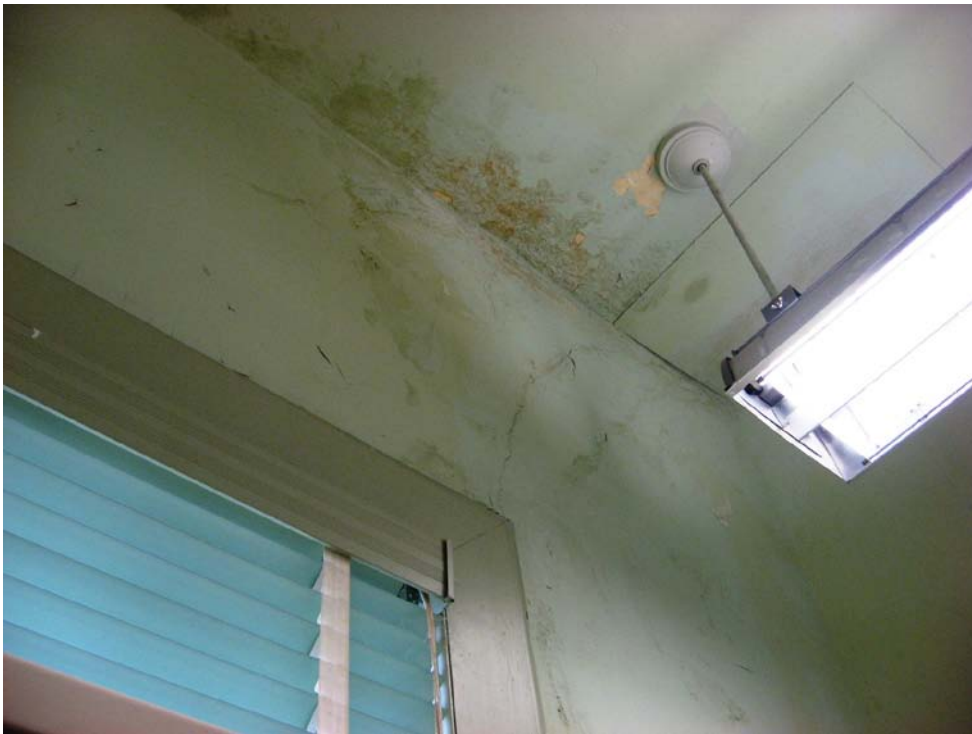
Cracks were observed at the interior plaster finish radiating from the corners of some of the windows (Photo P21-2). However, these cracks are minor, and, typically, do not indicate a deficiency in the structural system. In most cases, these cracks are the result of minor settlement.

Photo P21-2 – Minor cracks in plaster radiating from corner of window openings.
